4. QUALITY CONTROL

a. Tolerances and specifications

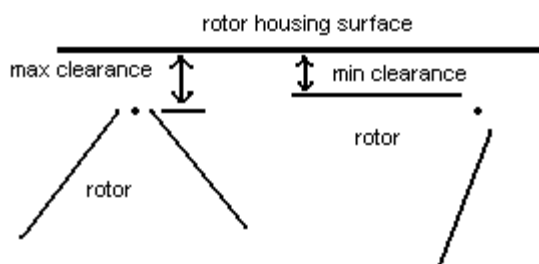
Another common misconception is that the clearance between the tip of the rotor and the rotor housings should remain constant along the entire trochoid surface. This is absolutely not true nor is it possible. This would be true only if the maximum angle of oscillation was to be 0° and this is not possible. The actual max angle of oscillation of the Mazda engines is in fact 26.2° and varies as the rotor spins. As the angle of oscillation varies between the max and min values the clearance between the rotor and the rotor housing also varies between the set max and min clearances. The following diagram illustrates the basic mechanism of “how” this happens:

Although this sketch is not technically correct it helps to illustrate how the clearance changes as the angle of oscillation changes.

The general Mazda guidelines for clearance are 0.017" to 0.030". The minimum practical clearance at TBC at the minor axis for a performance naturally aspirated engine (up to 300 hp) is about 0.010" to avoid rotor to housing contact, for forced induction motors this value is slightly higher; 0.014".

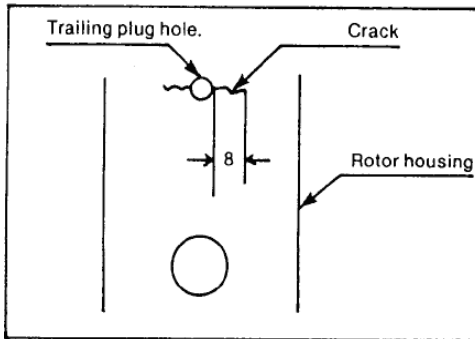
Cracking by trailing plug hole: The maximum allowable projection of these cracks by Mazda is 8mm as indicated in the diagram below. We can repair housing that do not meet these inspection criteria at an additional charge and recommend that this repair be done only to "special" housings that have been extensively modified and have a higher replacement value.

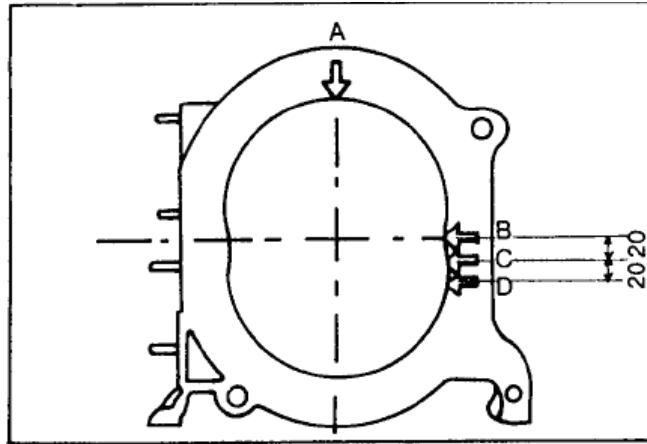
Rotor housings width: The rotor housing must be inspected to ensure the width is within the allowable limits. Measure the width or thickness of the rotor housing at points A, B, C and D as shown in the figure below. Points C and D are each 20mm steps, individually beginning at point B. Compare the dimension at point A with the smallest of the other three, whichever it is. If the difference is more than 0.06 mm the housing will not qualify as an acceptable core. We can repair housing that do not meet these inspection criteria at an additional charge and recommend that this repair be done only to "special" housings that have been extensively modified and have a higher replacement value.

Rotor housing width should be:

13B Engine 80mm (3.149")

12A Engine 70mm (2.756")
